HISTORIC STRUCTURE REPORT:  
THE CUSTOM HOUSE AND TOWER

VOLUME II:  
EXISTING CONDITIONS AND RECOMMENDATIONS

SARA B. CHASE  
and  
ANNE A. GRADY

SOCIETY FOR THE PRESERVATION OF  
NEW ENGLAND ANTIQUITIES  
CONSERVATION CENTER

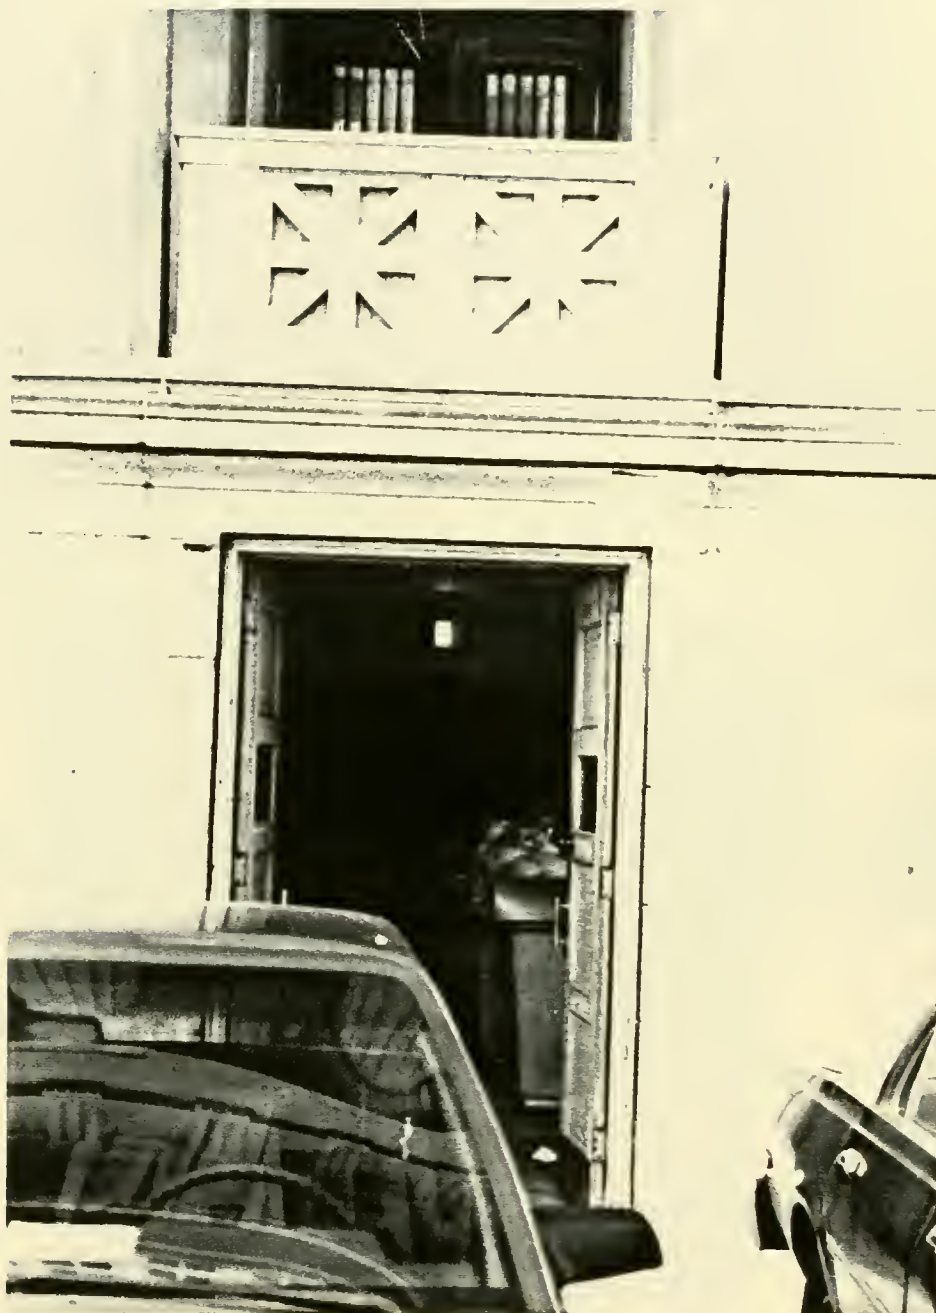
Figure 5

South side, street level  
Typical condition of all window lintels.

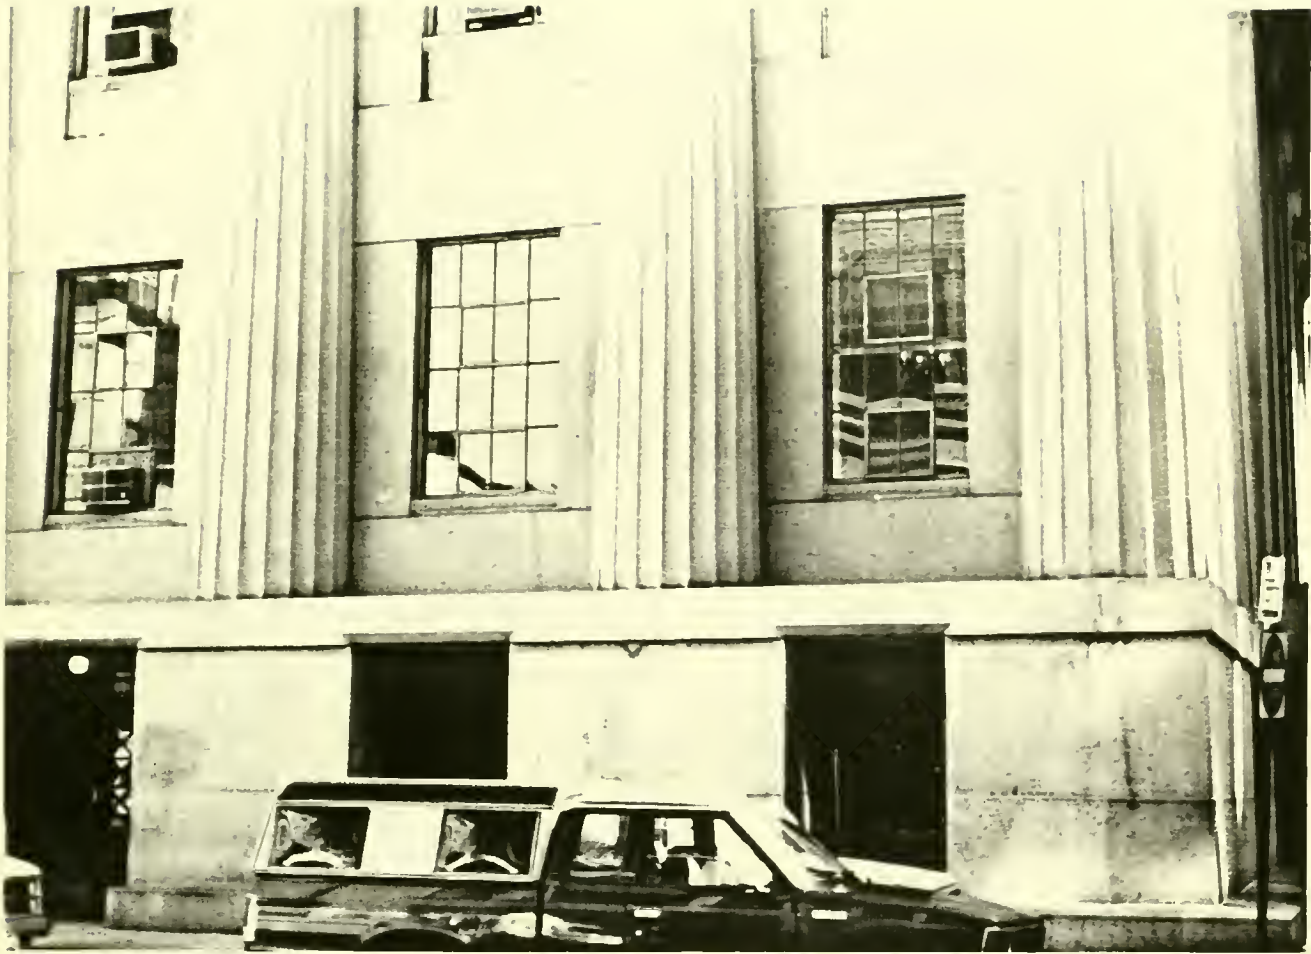
Figure 6

East entry, basement level

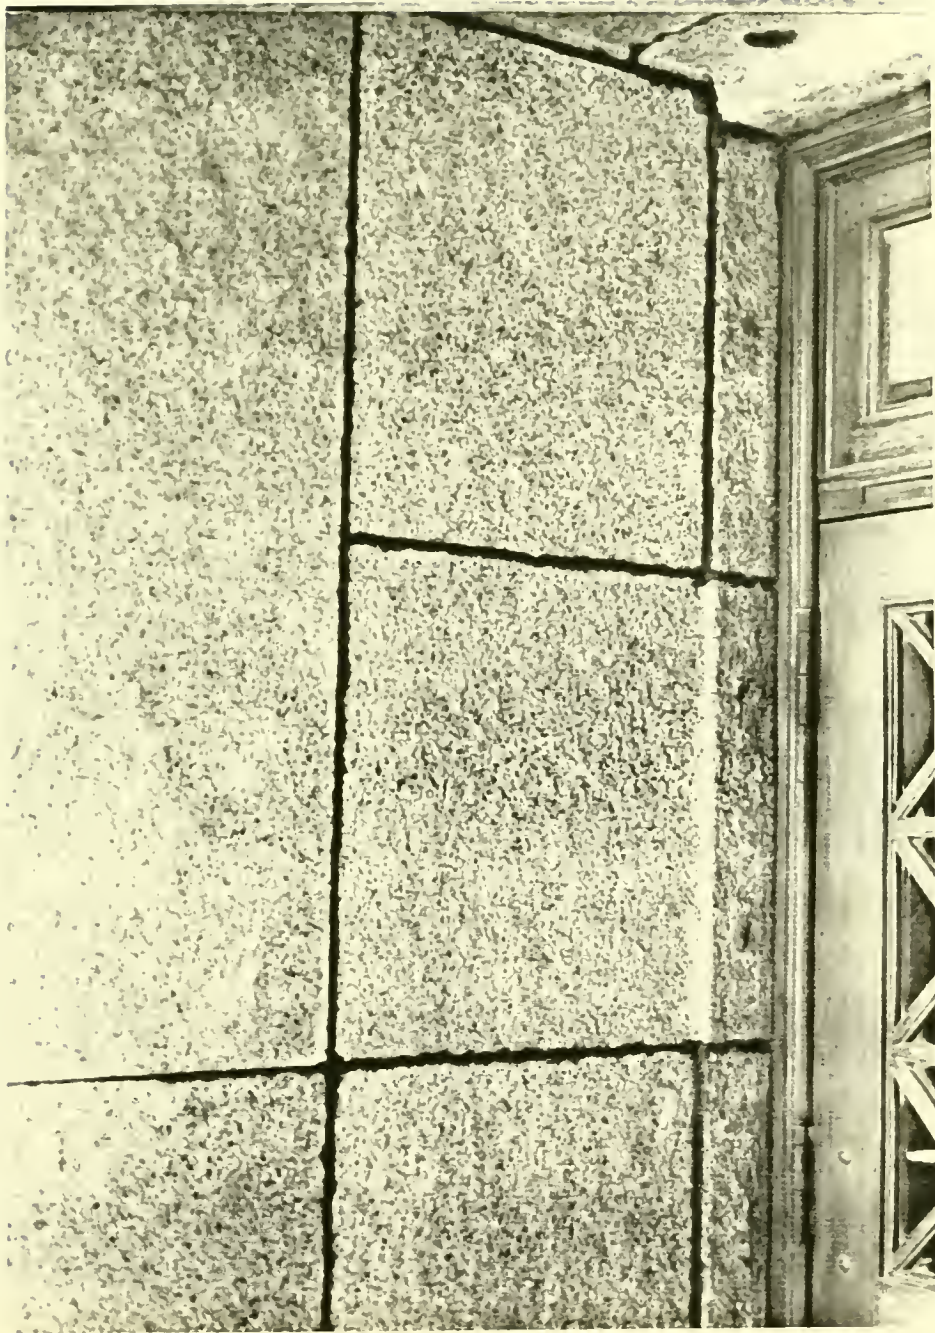
Figure 8

North basement entry

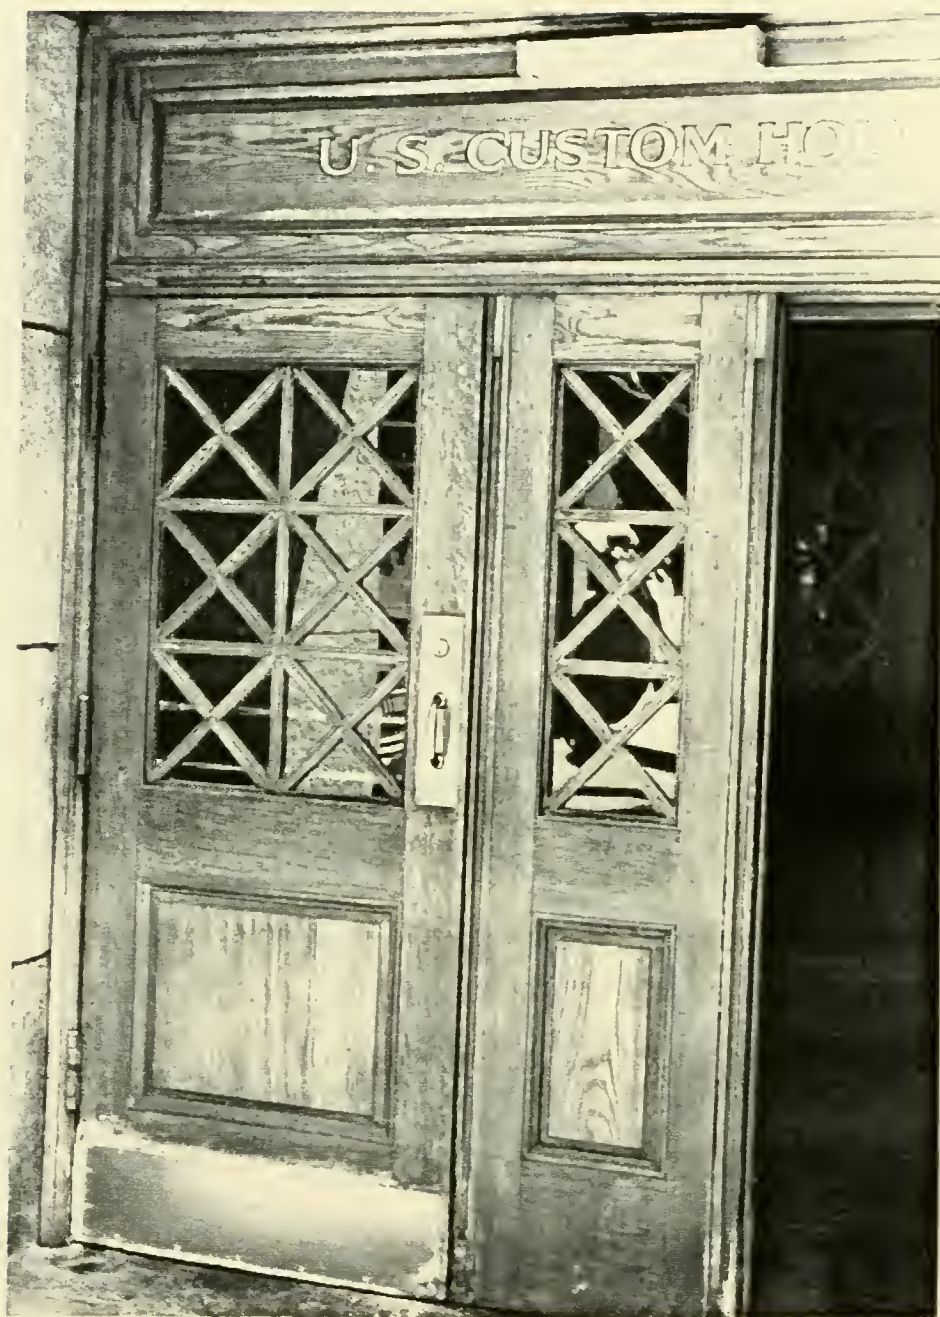
Figure 9

Black caulk at East side of  
North basement entry

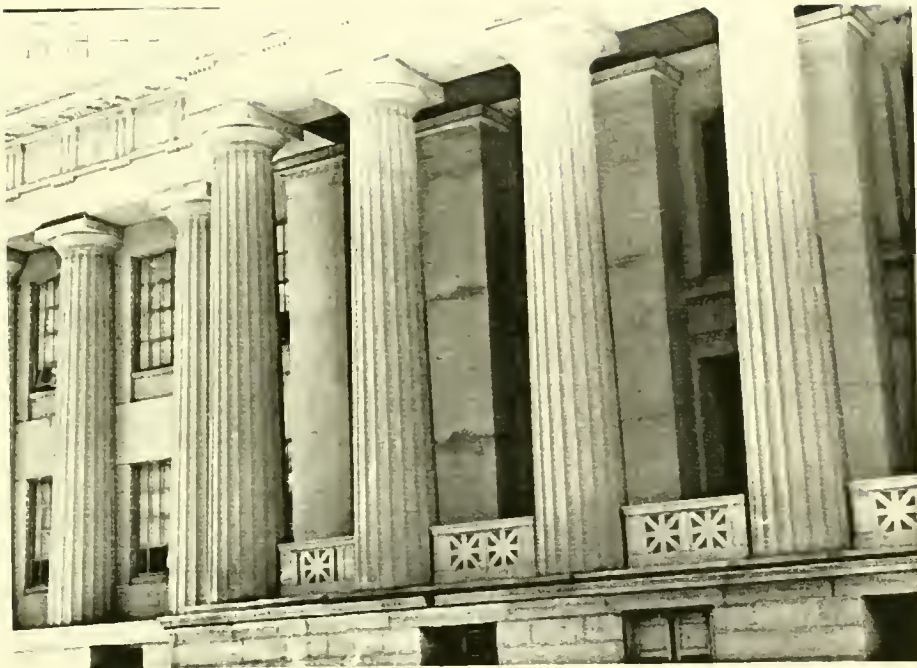
Figure 12

Basement window and South corner  
of portico base, East facade

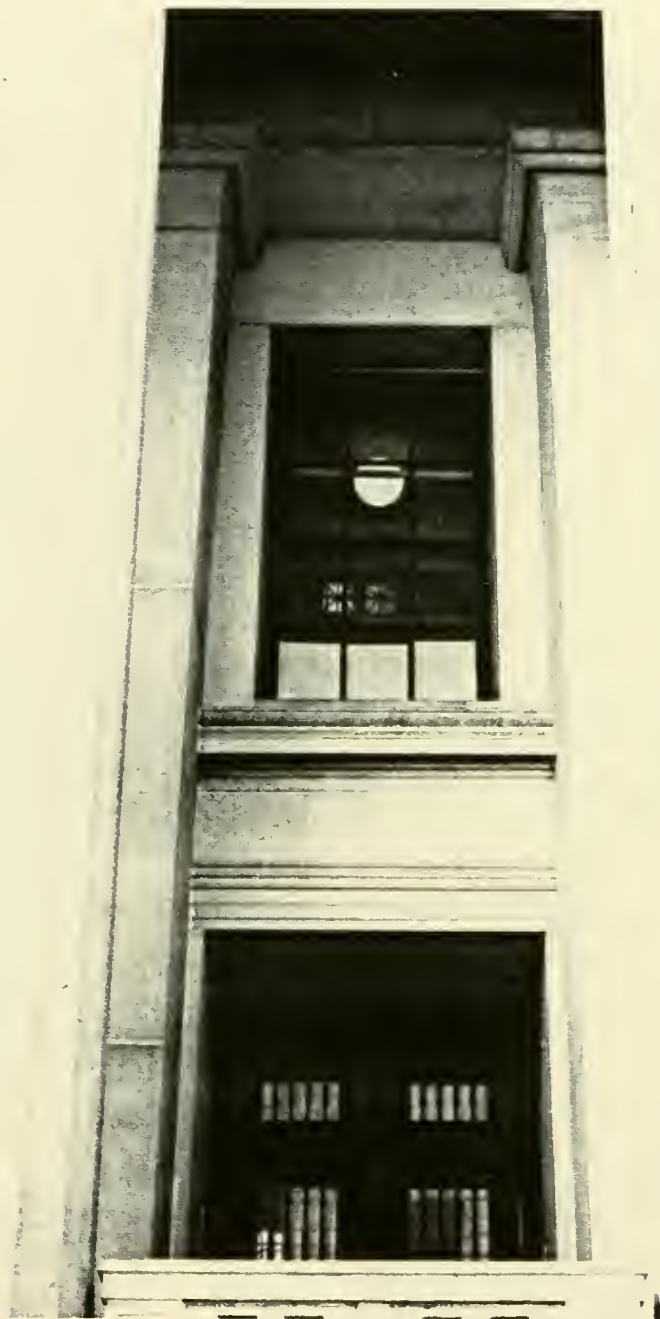
Figure 17

View of water stains, East facade,  
North corner of portico

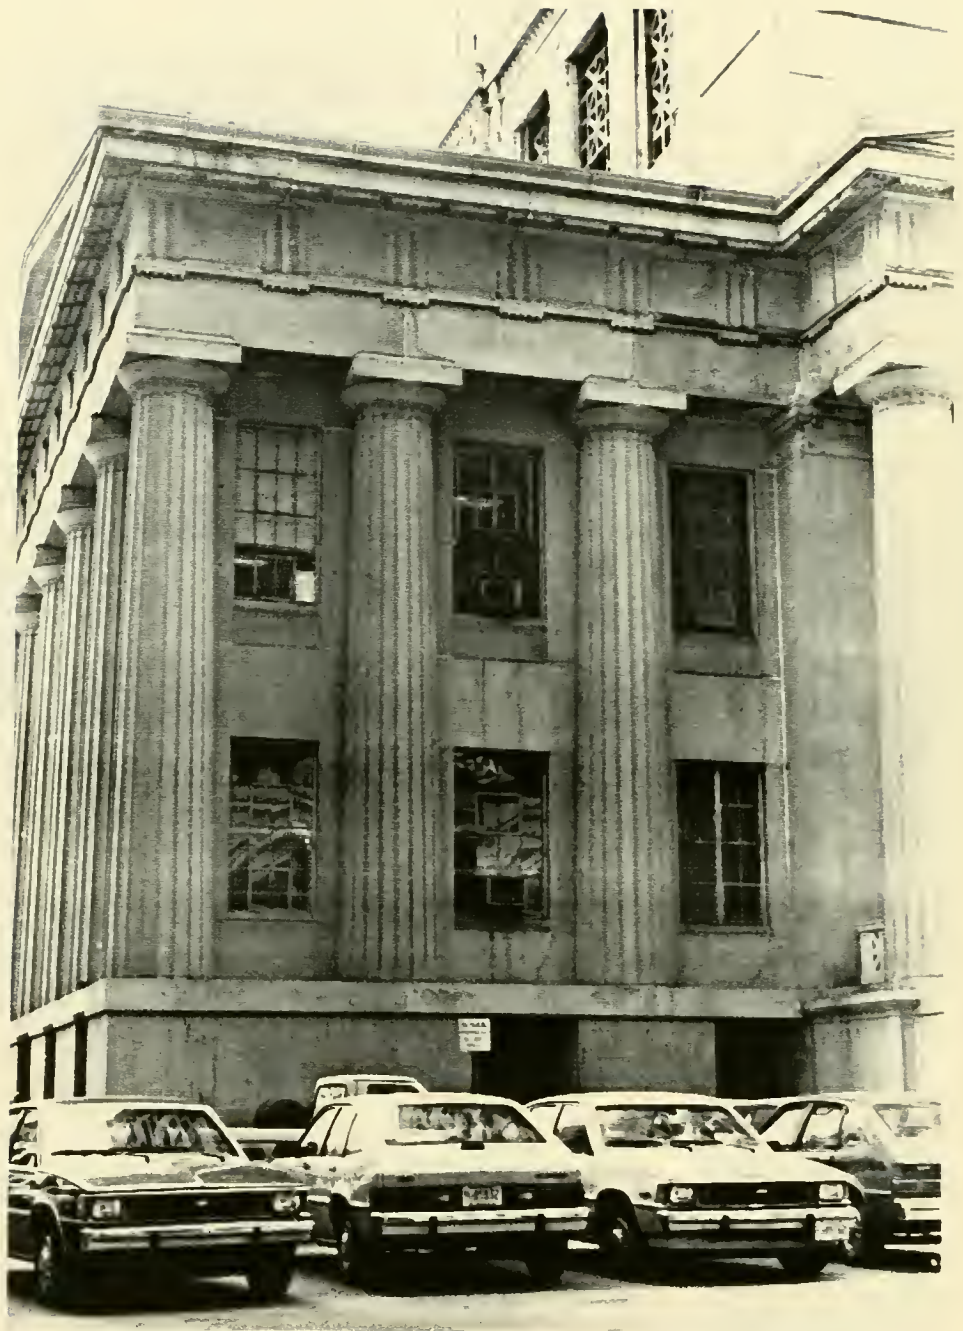
Figure 21

The most significant existing condition on the exterior of the Custom House is the building's lack of watertightness. In two areas in particular, water damage has gone on for some time: on the east side of the building, particularly on the east walls of the two major rooms of the north and south flanks of the Young portion of the building, and in the rooms above the twenty-fifth floor. The signs of damage caused by water are clear; in the major rooms there are sizable areas of paint loss, skim-coat peeling, and efflorescence on the plaster, some of which is decorative work dating from the Mullett period of the late 1860s. The rooms near the top of the Tower have a perpetual smell of damp stone and plaster, and varying amounts of efflorescence are visible. Another area which shows severe damage along the east wall is the area around the dome. Peabody and Stearn's design in this area provides for light to filter into the rotunda by having the floor around the dome's structure set with glass blocks of the sort that exist outside the building in some of the basement light wells. These blocks permit transmittal of light from the large windows in the exterior walls of the dome area. One might think that the windows are leaking on the east wall, but such examination as we could do did not seem to confirm that.

East wall. Dark areas correspond with  
severe interior water damage.

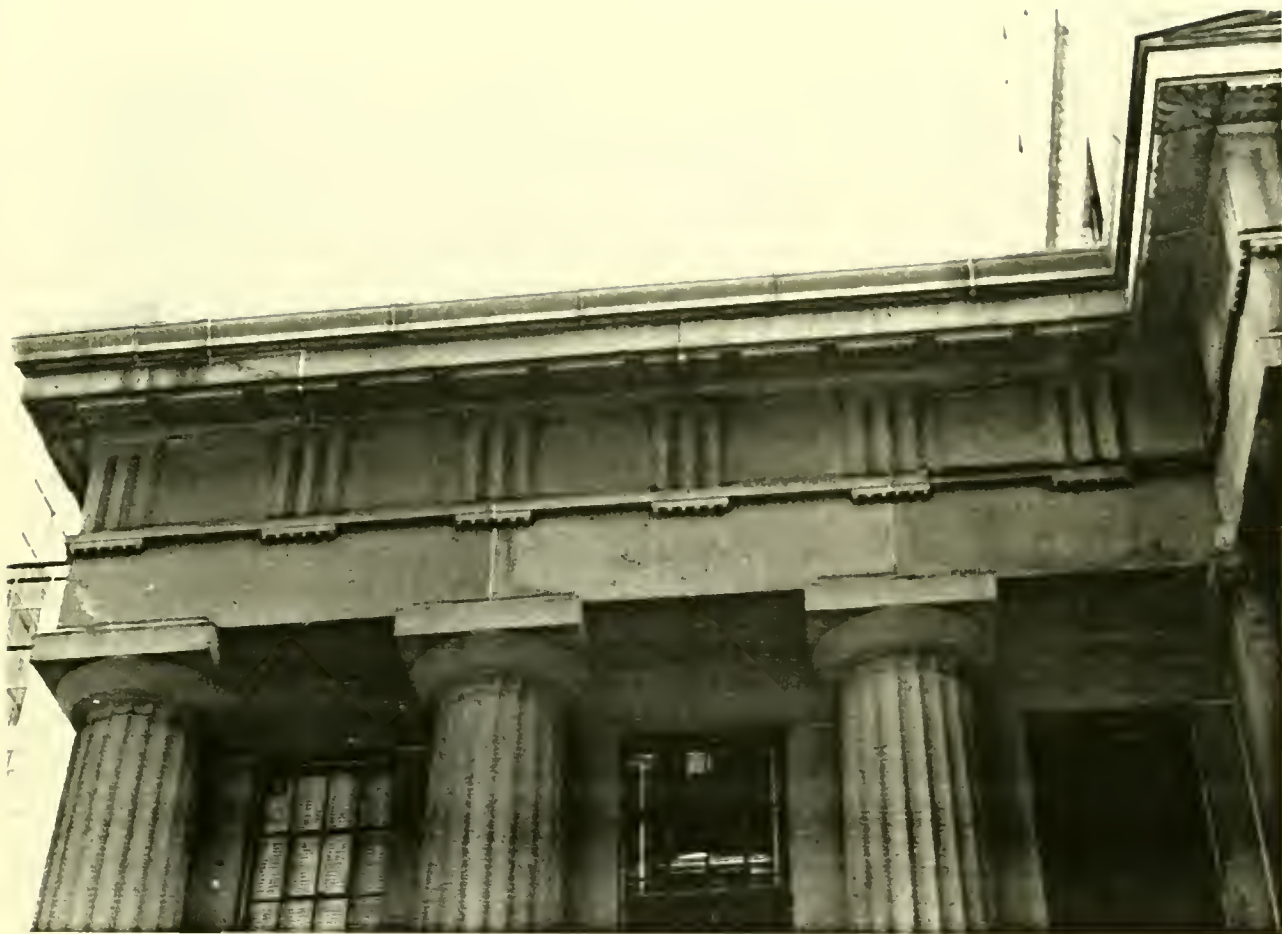
Figure 22

View of West wall  
to North of West Entry

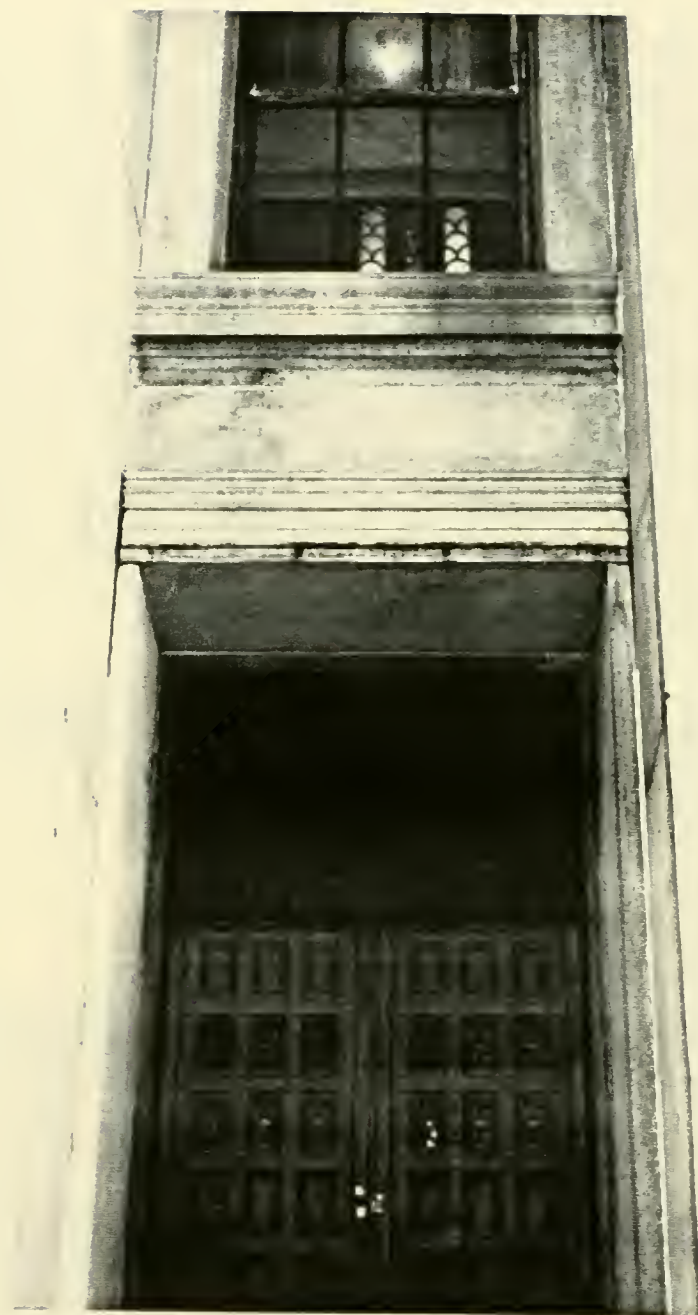
Figure 25

West side, South corner  
Typical remnants of sign adhesive

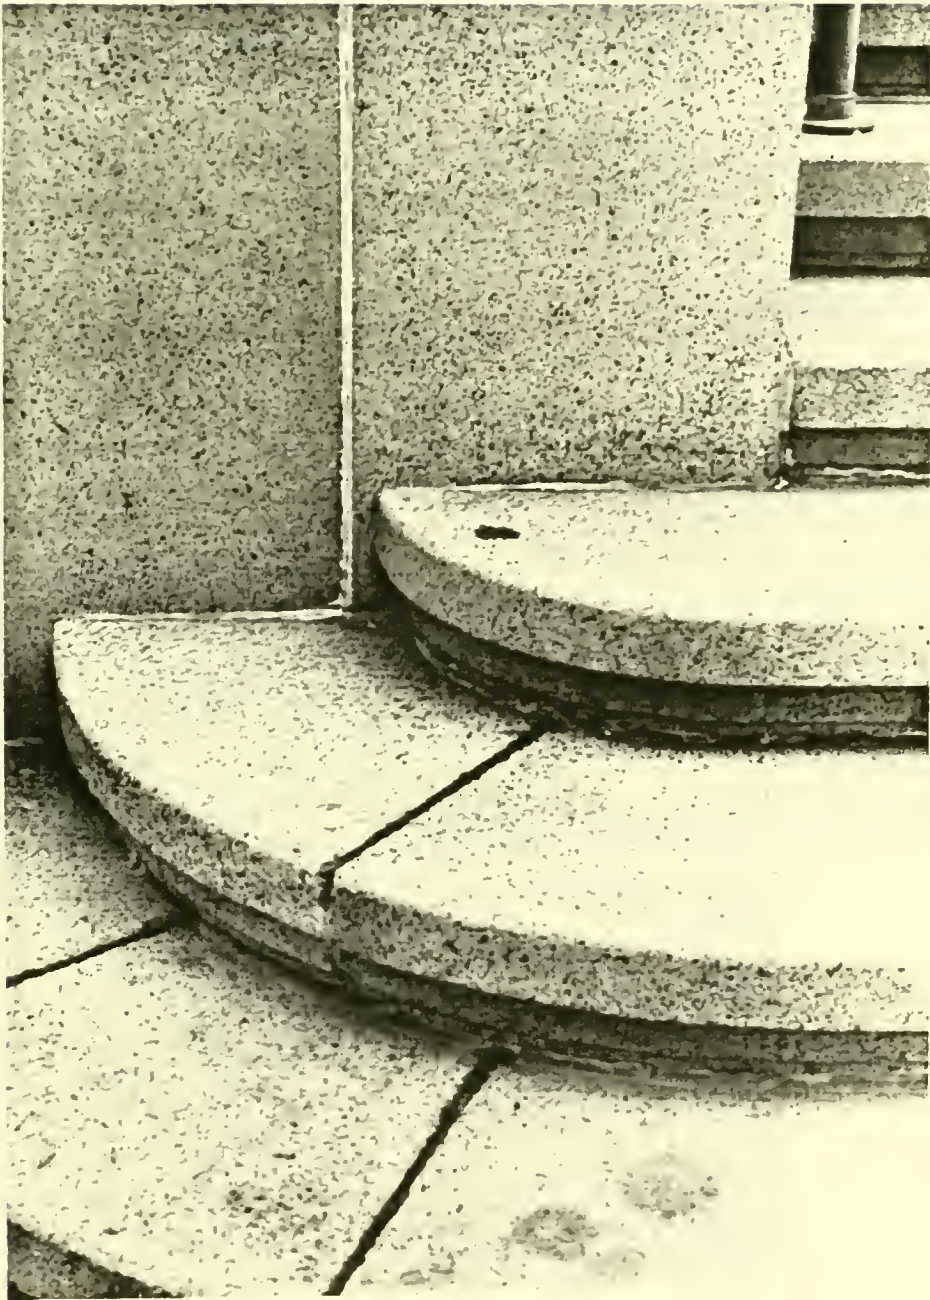
Figure 26

West Entry, 1st floor

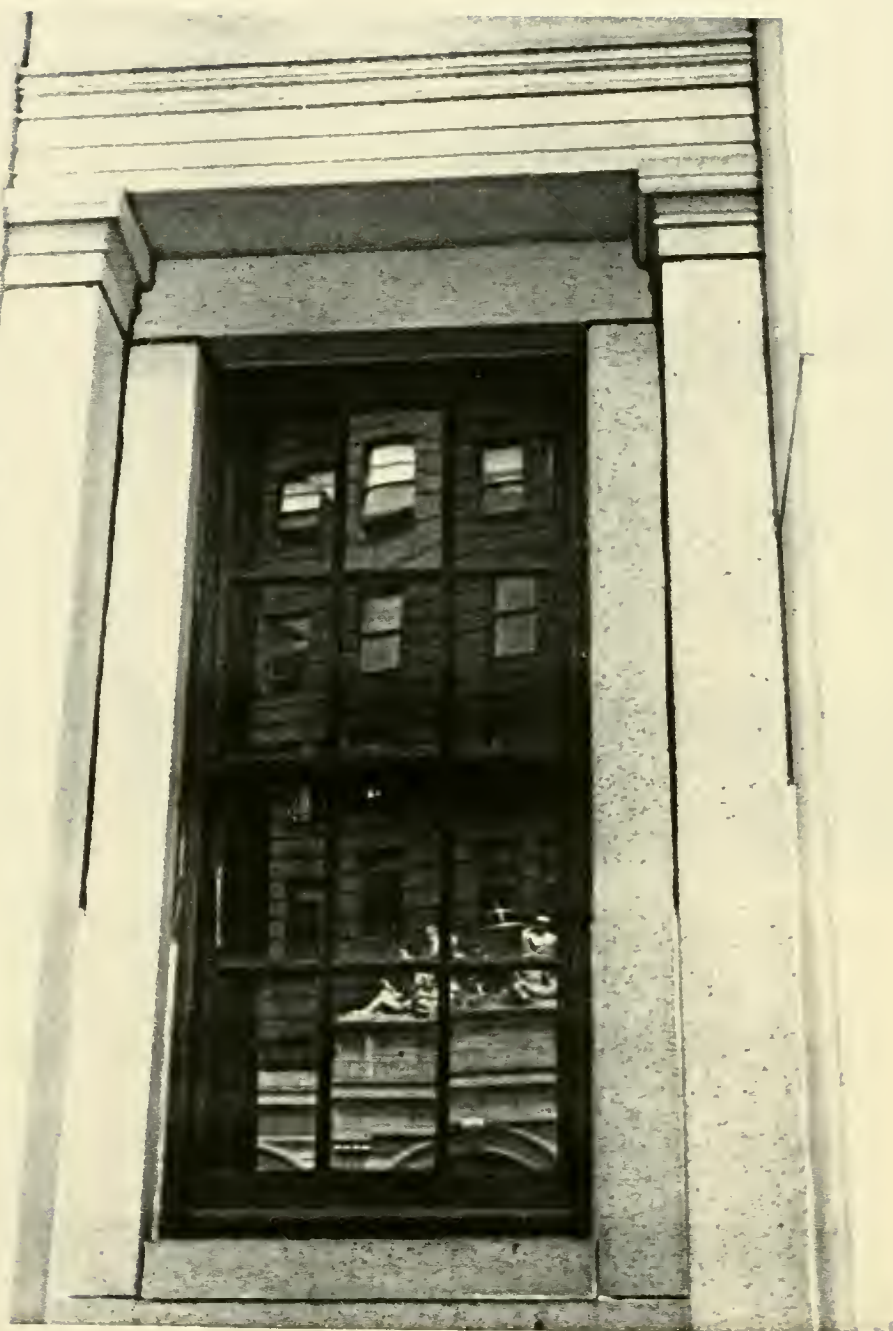
Figure 31

First Floor window, East wall  
(Typical conditions)

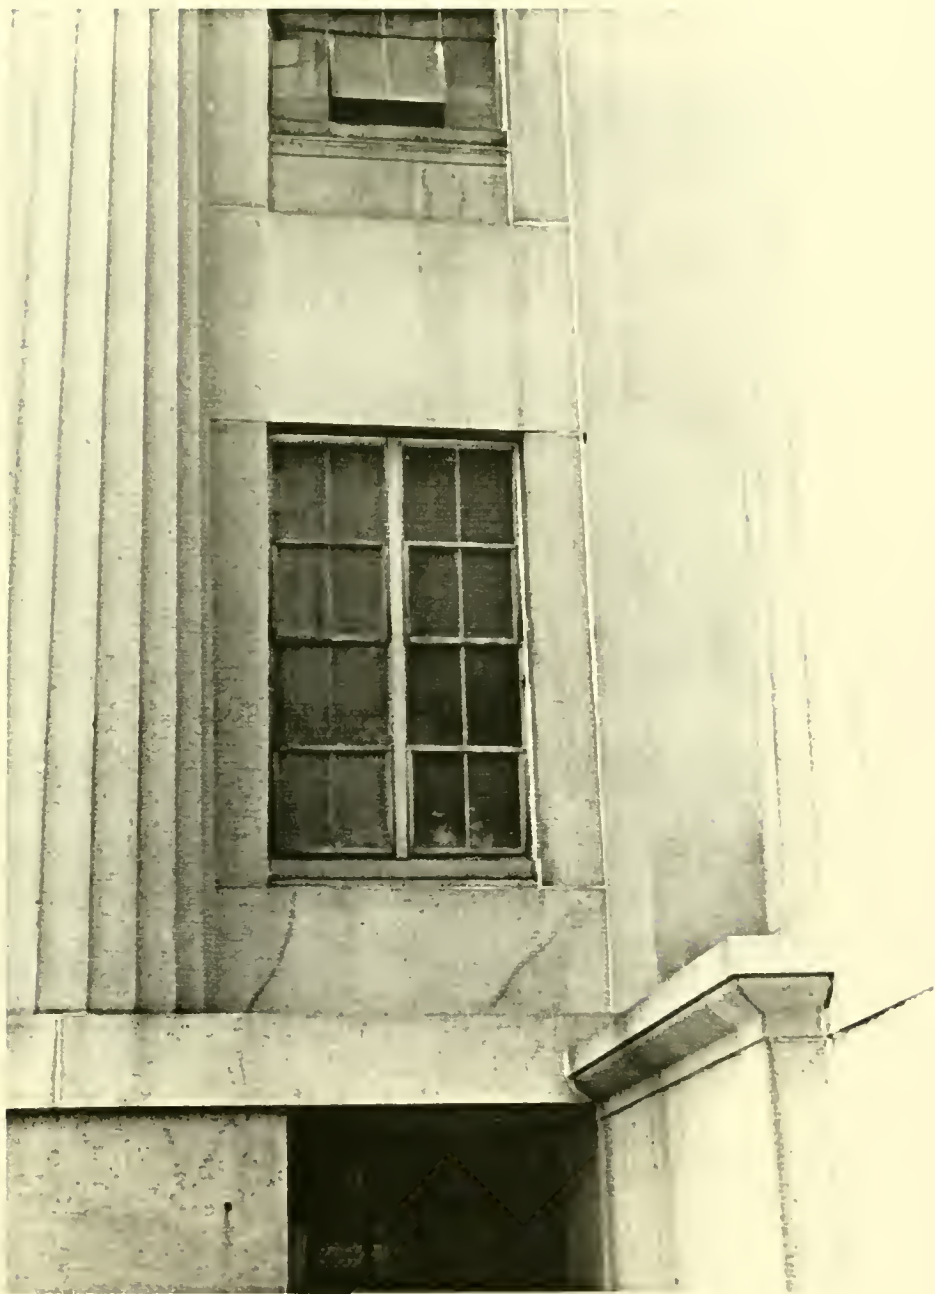
Figure 32

West wall, window over Entry (2nd floor)

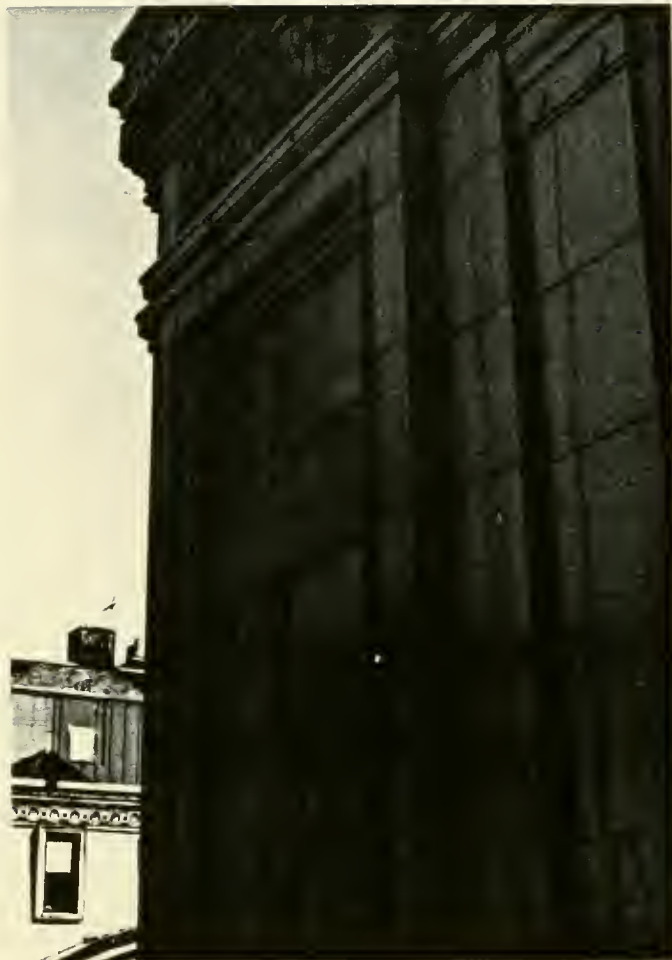
Figure 33

1st floor window on West wall,  
North of Entry (Typical conditions)

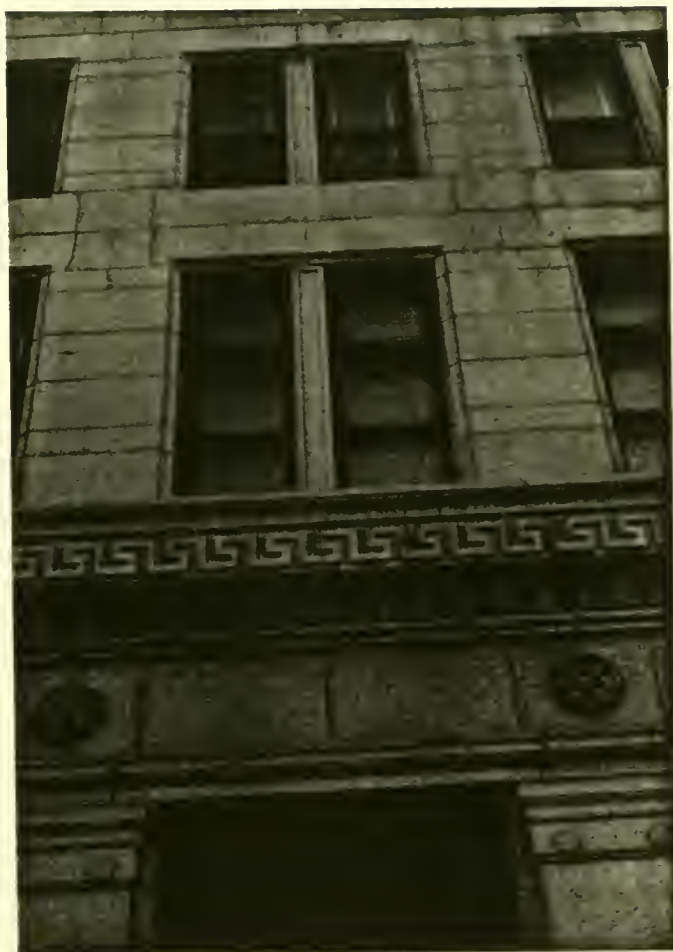
Figure 34

East corner of North wall, dome area

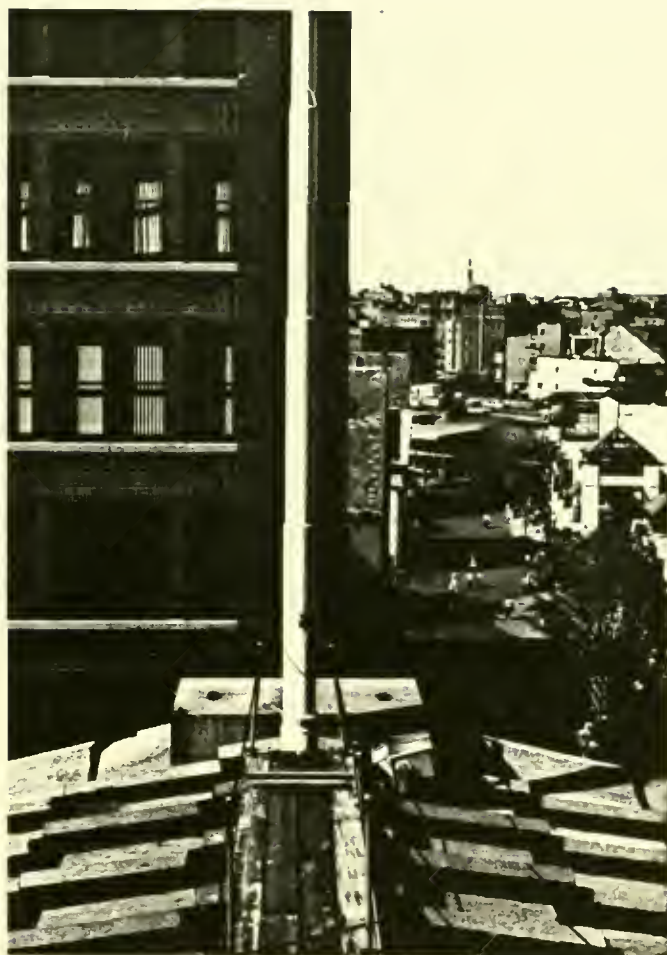
Figure 38

South face of Southeast corner

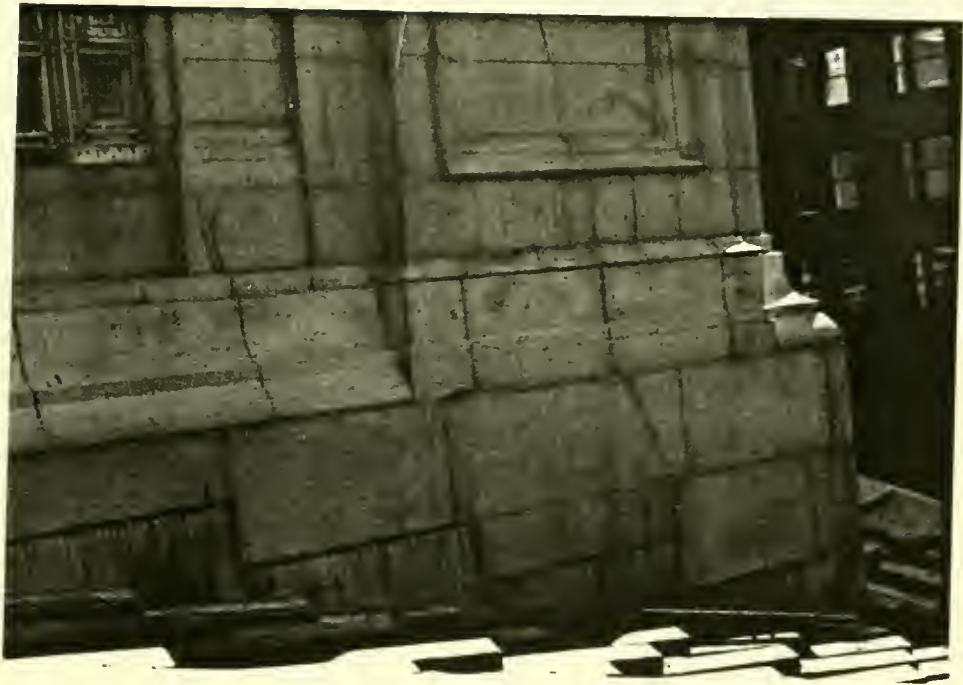
Figure 40

Northwest corner of West slope of North roof

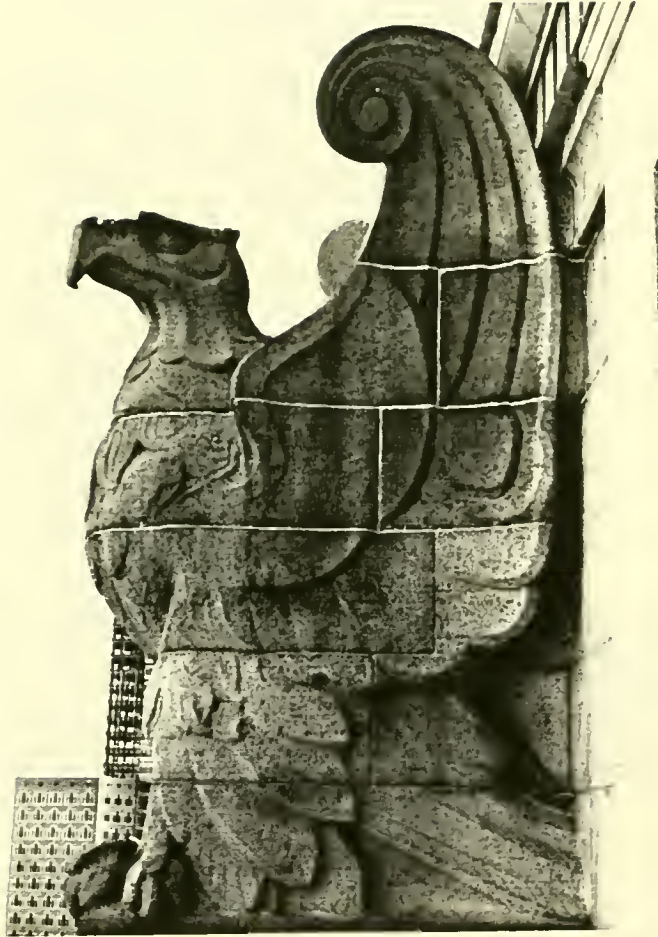
Figure 48

Eagle on Southwest corner of balcony  
Floor 20

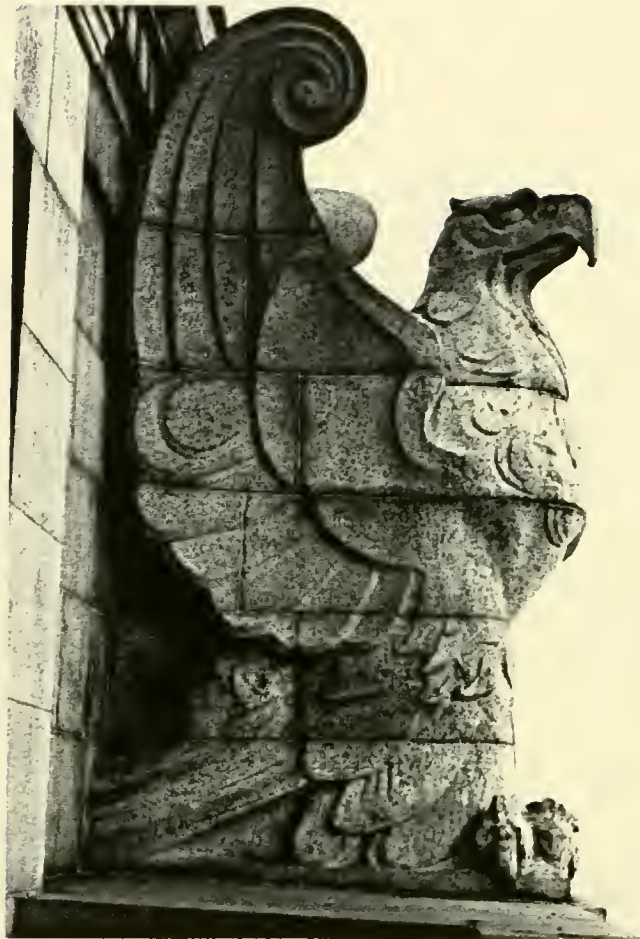
Figure 49

Eagle on Southeast corner, 20th floor.  
More white caulk.

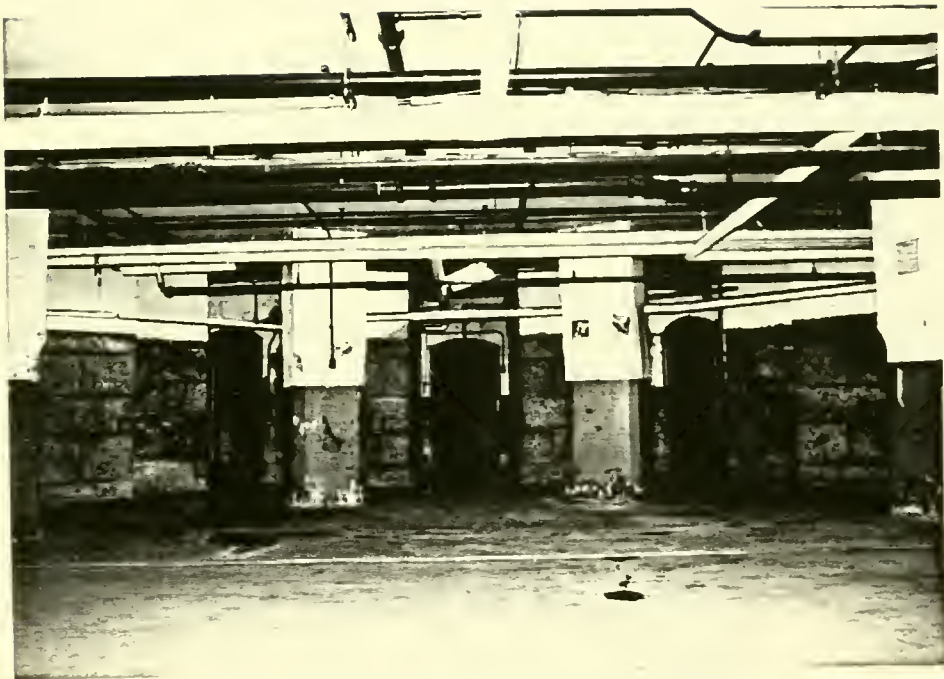
Element	Material/Description	Condition	Photo#
Floor	concrete	fair, painted at least 4 layers peeling [red, grey, lt. grey, present grey]	SB-1
Base-board	None		
Walls	granite & plaster	rough cut, painted, fair; 8 layers of paint including ivory, tan, green	SB-1,2
Cornice	none		
Ceiling	plaster	very poor - calcimine peeling	SB-1
Windows	none		
Window Frames	iron frames of sidewalk lights	very rusted	
Doors	painted metal	only 2 left	
Door Frames	painted metal	good	
Hardware	iron and steel	fair - good	SB-1
Elect. Fixt.	egg crate	fair	
Square stone columns	granite	parged w/ 2-3 1/2" layers of concrete

Remarks: joints in walls newly pointed w/ grey cement - too wide iron frame of central frosted oculus in ceiling is corroded.

SB-1; Rotunda, looking west.

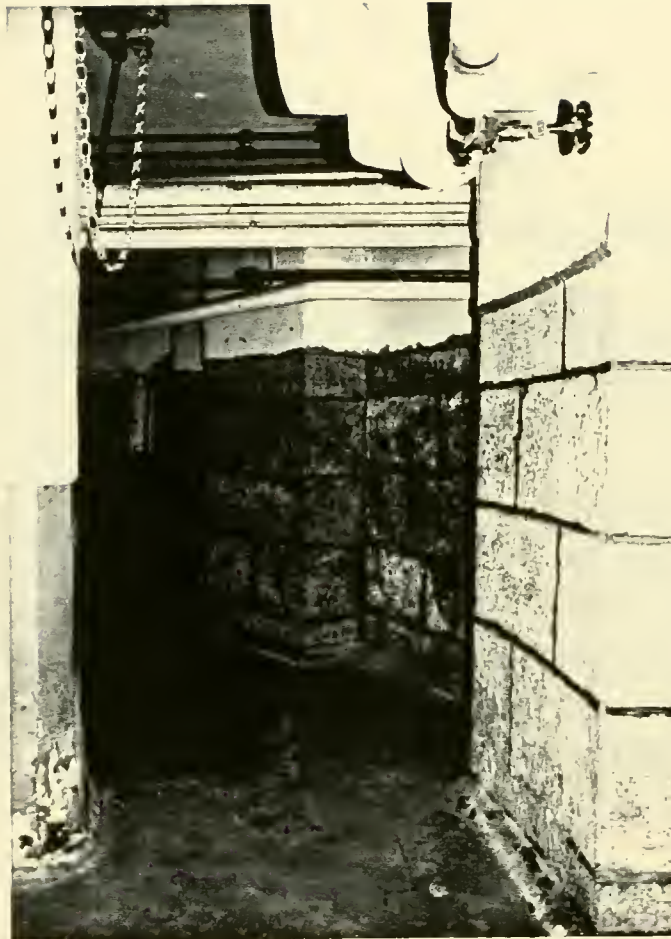
SB-2; New granite piers laid up against original granite walls of rotunda.

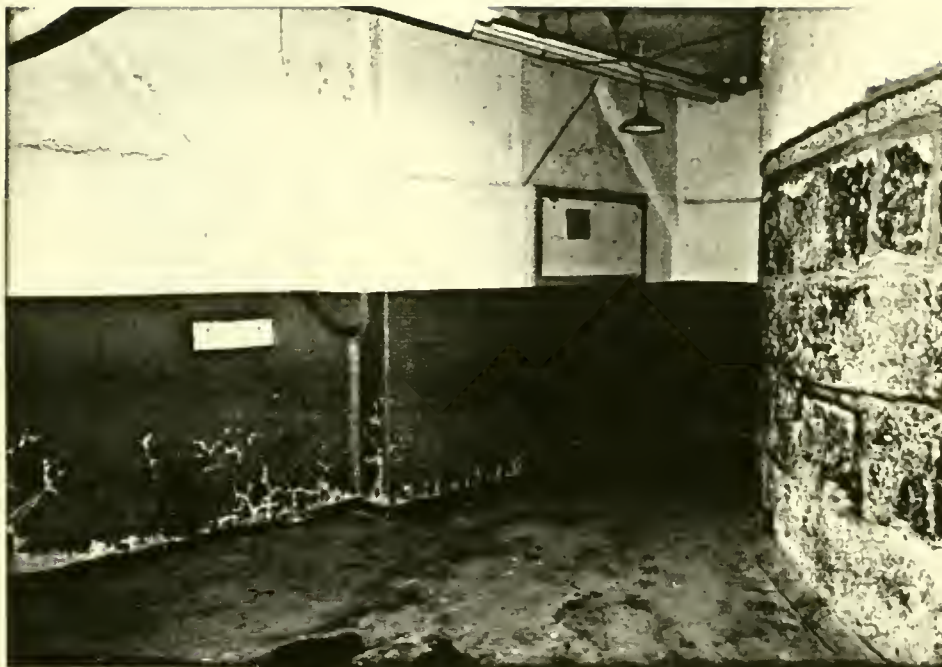
Material/Description		Condition	Photo#
Base-board	none		
Walls	granite, brick, plaster	painted; fair - good	SB-3
Cornice	none		
Ceiling	plaster	fair; peeling paint and skim coat	SB-7
Windows	none		
Window Frames	none		
Doors	none (?)		
Door Frames	metal	painted iron; OK	
Hardware			
Elect. Fixt.			
Special Features			
Remarks

SB-3; Storage room, southeast of rotunda.  
Note 1837 rotunda wall (right) and 1912 wall  
containing tower substructure (left).

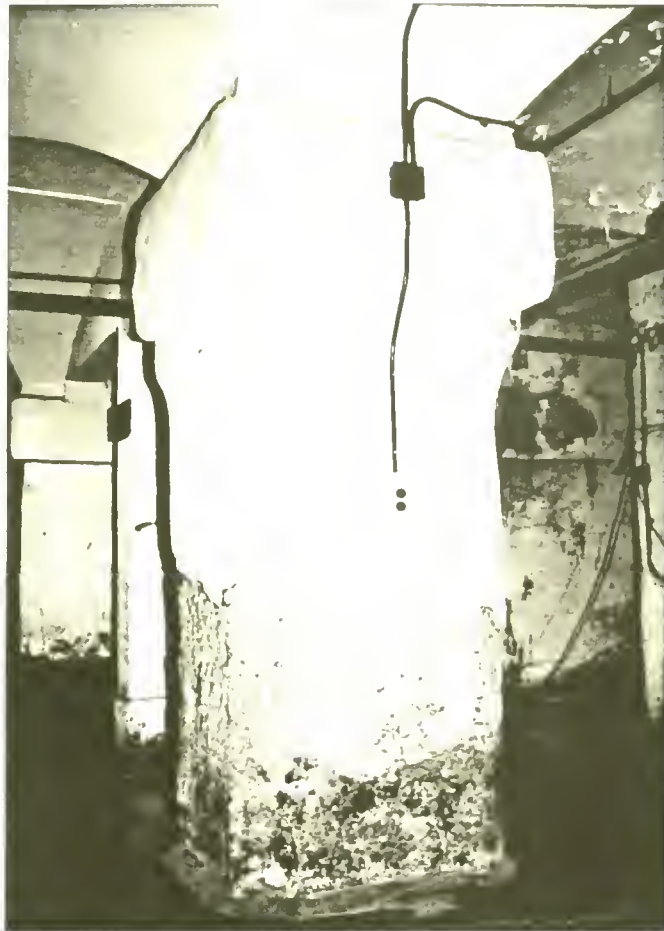
Material/Description		Condition	Photo#
Floor	concrete	poor; <u>standing water</u> in 90% of this area	SB-4
Base-board	none		
Walls	granite, brick	fair; painted and in places plastered	
Cornice	none		
Ceiling	plaster	fair; poor - Paint peeling	SB-5
Windows	none		
Window Frames	sidewalk light frames are iron	very rusted	
Doors	none		
Door Frames	none		
Hardware	none		
Elect. Fixt.	egg crate		
Special Features			
Remarks

SB-5; 1837 granite pier and vault springing, south wing.

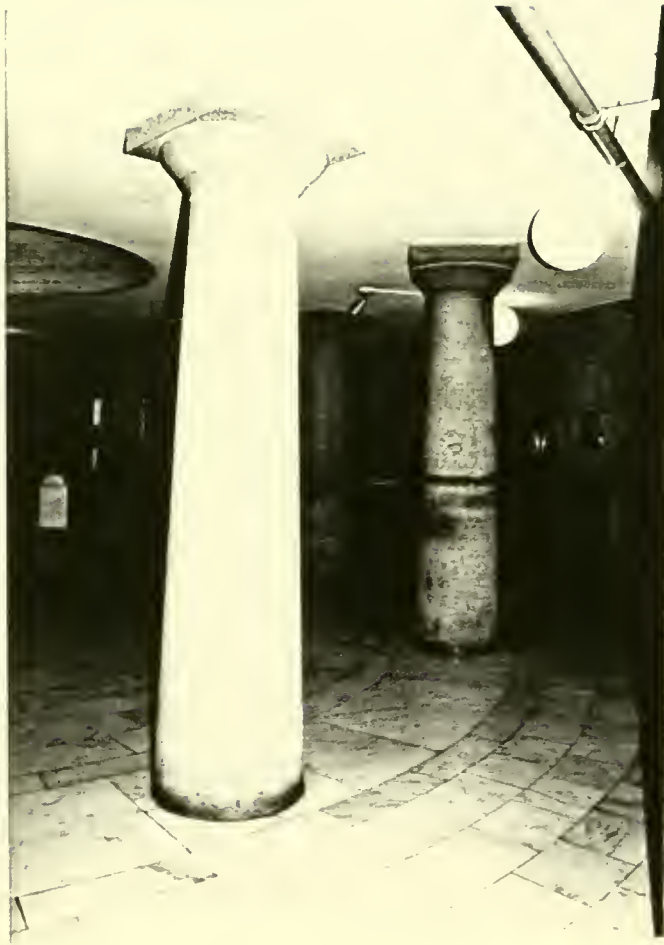
Material/Description		Condition	Photo#
Floor	white marble	good, but somewhat soiled with all joints blackened	B-1 B-18
Base-board	none		
Walls	granite	irregularly soiled, joints generally sound, some bad reprinting	B-2
Cornice	granite	fine, a bit dusty	B-15
Ceiling	flat plaster under gallery	good	B-1, 18, 1-4
Windows	none		
Window Frames	none		
Doors	oak (N & S only)	minor cleaning and touch-up varnish	
Door Frames	oak (N & S only)	(same as above)	
Hardware	brass	fine, but polish has spread onto wood	
Elect. Fixt.			
Special Features	granite columns	very soiled, especially at bases	B-1
Remarks: Signs have marred the granite walls in many areas; new grapevine joints not appropriate.

B-1; Rotunda.

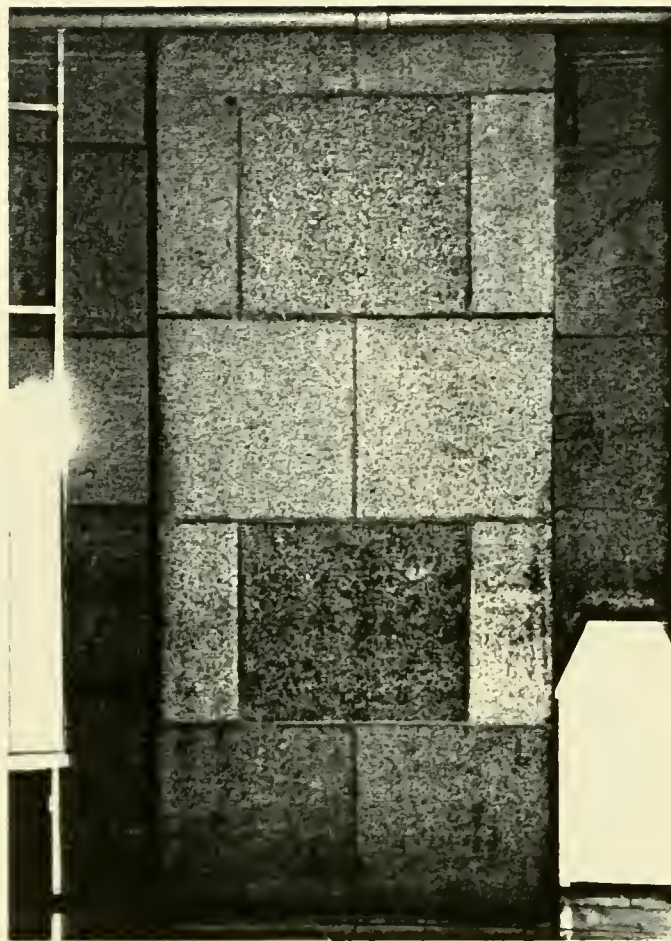
B-2; Rotunda, northeast wall.

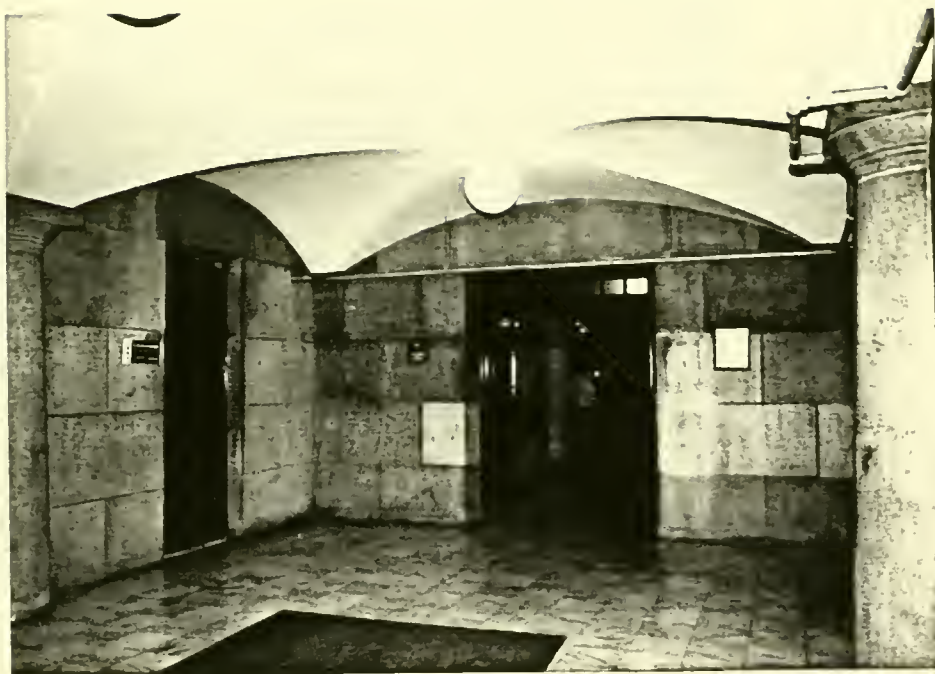
Element	Material/Description	Condition	Photo#
Floor	marble	highly waxed, joints dark, some chipped edges	B-5, 6
Base-board	none		
Walls	granite	dirty, floor wax on lower edges	B-5, 6
Cornice	none		
Ceiling	vaulted plaster	some cracks, peeling paint; ivory, cream, pale grey paints	B-5, 6
Windows	none		
Window Frames	none		
Doors	exterior: oak interior: grained metal	exterior needs refinishing, interior some chipped and crazed areas, some dirt	B-6, 7, 8
Door Frames	same as above		
Hardware	exterior: brass interior: brass	highly polished tarnished	B-6, 7, 8
Elec. Fixt.	frosted glass globes		B-5, 6
Special Features

B-5; South corridor, looking north.
